Manhole Inspection Summary

Manhole # S39MM_028MH

Insp Date: **3/1/07 1:56 PM**

Location Address: **1901 KENNEDY AVE**

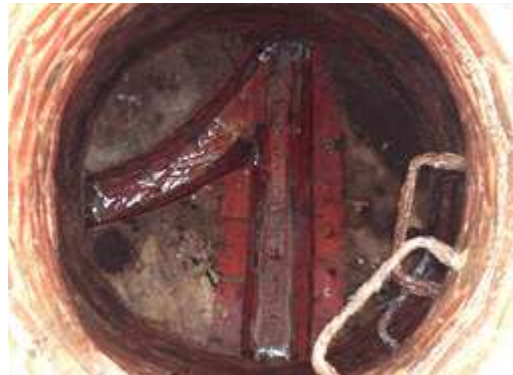
Top View

Corroded steps Evidence of surcharge - Bench debris.

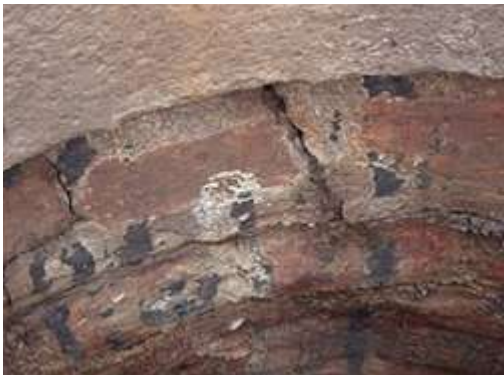
Defect

Frame leaks. Corbel deterioration, cracks and infiltration.

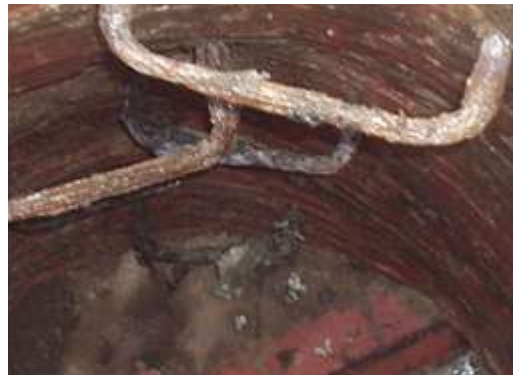
Defect

Barrel infiltration. Evidence of surcharge - Bench debris.

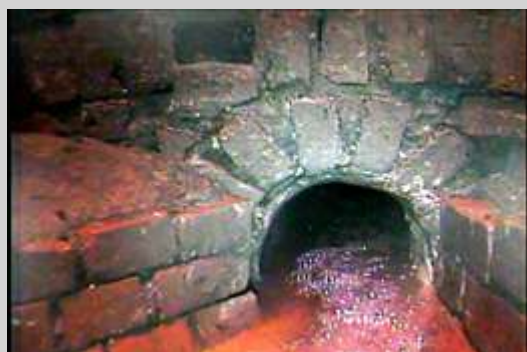
Pipe Out @ 12 O'Clock

Channel deterioration.

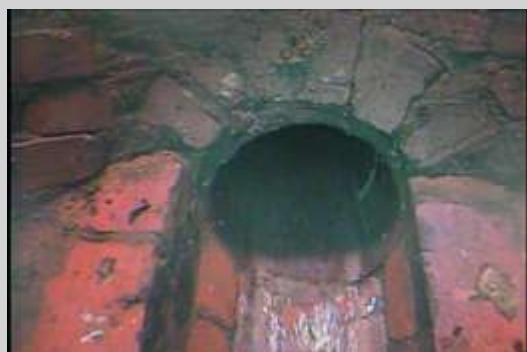
Pipe In @ 6 O'Clock

Infiltration: **Evidence** Pipe Seal Cond: **Unknown**
